Disaster Safety Review

Photovoltaic Arrays: High Wind Research

Relative Impact Resistance of Asphalt Shingles

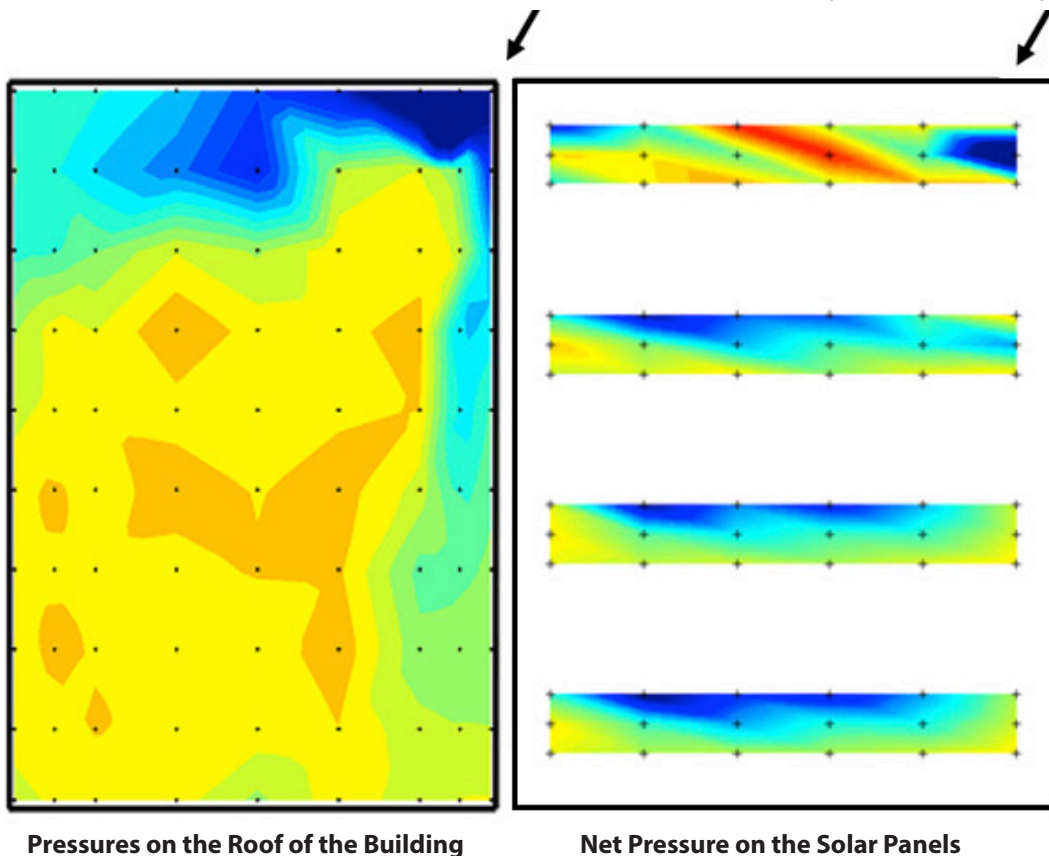
Figure 2. Wind pressures on the roof of a building (left), and net loads on solar panels on the roof (right).

Figure 2 shows a comparison of wind pressures on the roof surface of a building to the net wind loads on solar panel arrays from a cornering wind direction of 30 degrees as shown. The solar panels shown are elevated 5.5" above the roof surface and have a panel inclination relative to the roof of 10 degrees. For the roof surface, the highest wind loads (dark blue) are near the edges of the buildings. In contrast, solar panels have higher wind loads near the center of the building. This demonstrates the distribution of wind loads on the roof of the building can be substantially different from the distribution of wind loads on solar arrays.

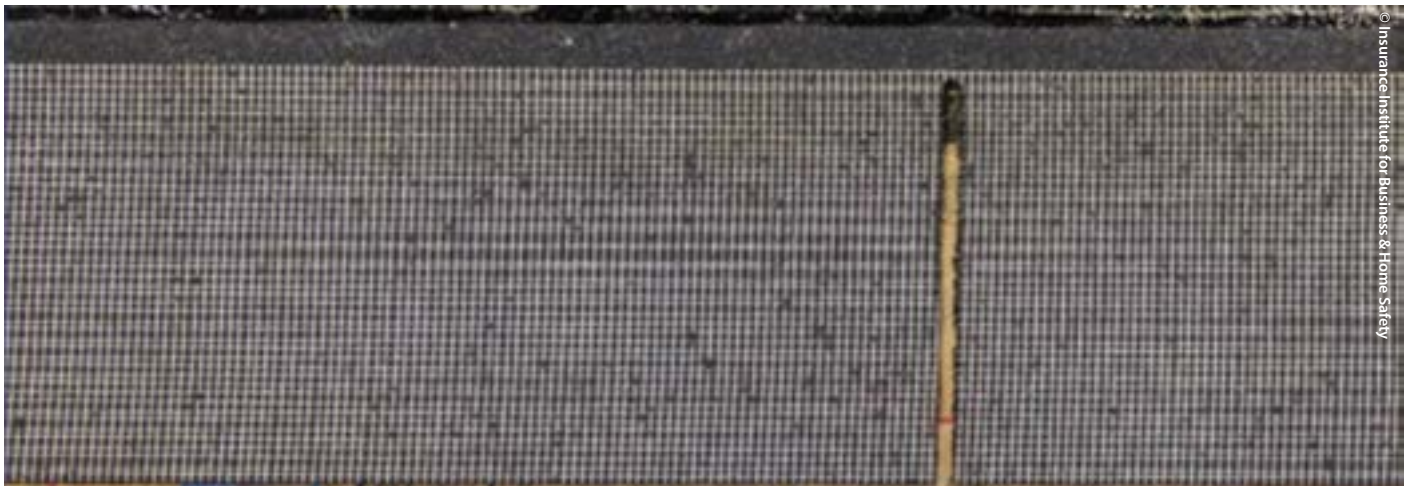
Figure 1: Example of mesh on the back of an IR 3-tab shingle.

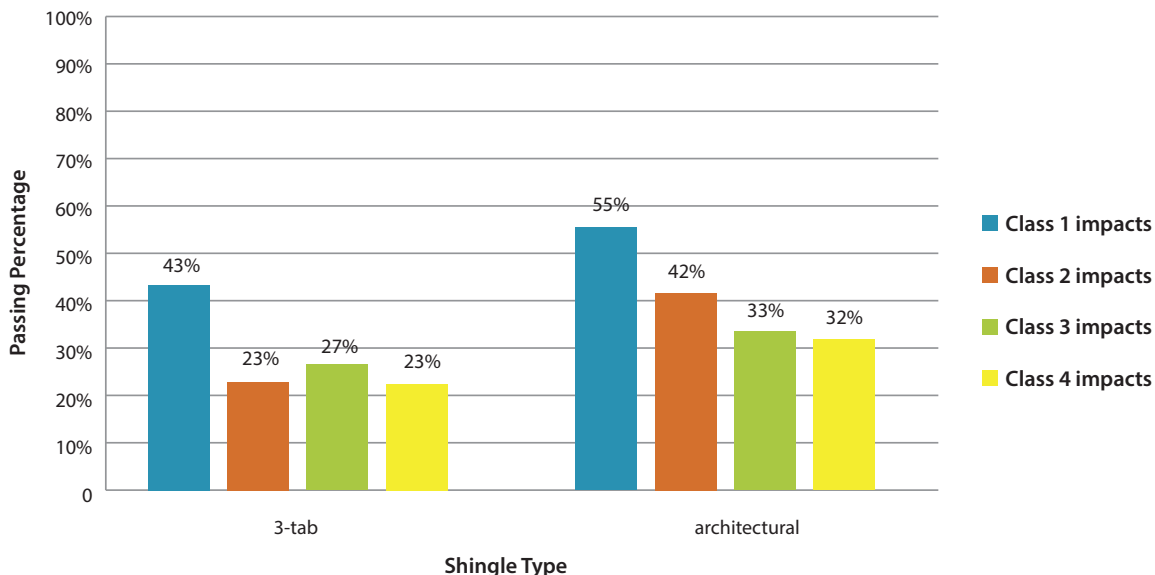
**UL 2218 Impact Location Passing Rates:
3-tab vs. Architectural Shingles**

Figure 4. Comparison of basic 3-tab and basic architectural shingle performance to Class 1-4 impacts.

- a. Class 1 UL 2218 impacts resulted in passing ratings for about 45 percent of the impact locations for 3-tab and about 55 percent of the impact locations for architectural shingles.
- b. Class 2 UL 2218 impacts resulted in passing ratings for about 25 percent of impact locations for the 3-tab and about 40 percent of the impact locations for the architectural shingles.
- c. Class 3 UL 2218 impacts resulted in passing ratings for about 25 percent of impact locations for the 3-tab and about 35 percent of the impact locations for the architectural shingles.
- d. Class 4 UL 2218 impacts resulted in passing ratings for about 25 percent of impact locations for the 3-tab and about 30 percent of the impact locations for the architectural shingles.

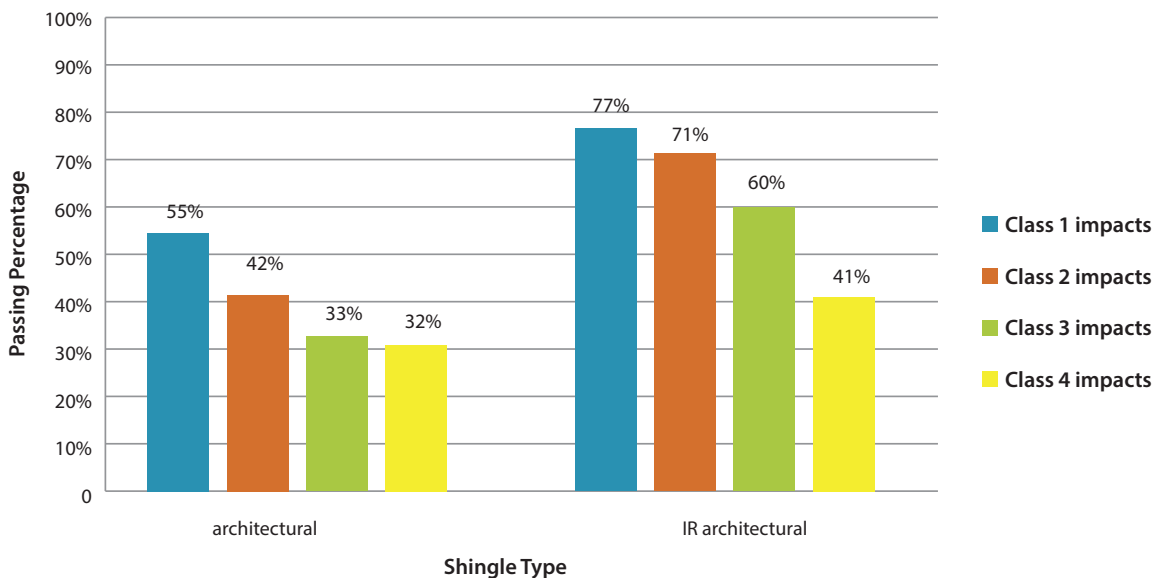
**UL 2218 Impact Location Passing Rates:
Architectural vs. IR Architectural Shingles**

Figure 6. Comparison of basic and IR architectural shingle performance to Class 1-4 impacts. It should be noted that the IR products are rated to withstand Class 4 impacts.

- a. Class 1 UL 2218 impacts resulted in passing ratings for about 75 percent of the impact locations on the IR architectural shingles versus about 55 percent for the basic architectural shingles.
- b. Class 2 UL 2218 impacts resulted in passing ratings for about 70 percent of the impact locations on the IR architectural shingles versus about 40 percent for the basic architectural shingles.
- c. Class 3 UL 2218 impacts resulted in passing ratings for about 60 percent of the impact locations on the IR architectural shingles versus about 35 percent for the basic architectural shingles.
- d. Class 4 UL 2218 impacts resulted in passing ratings for about 40 percent of the impact locations on the IR architectural shingles versus about 30 percent for the basic architectural shingles.

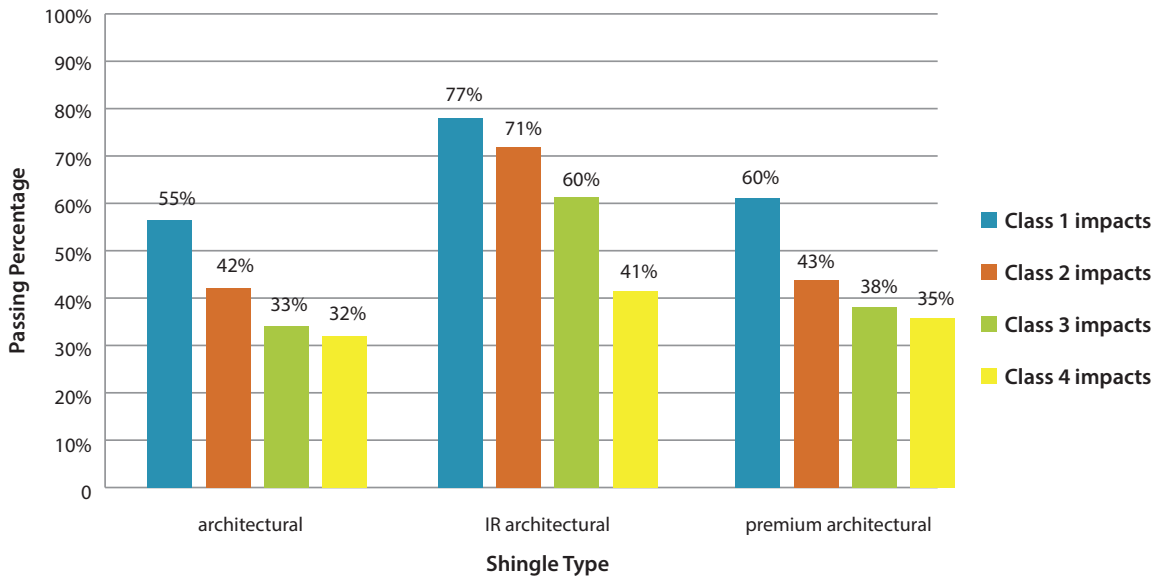
**UL 2218 Impact Location Passing Rates:
Architectural , IR Architectural and Premium Architectural Shingles**

Figure 7. Comparison of basic and IR architectural shingle performance to Class 1-4 impacts. It should be noted that the IR products are rated to withstand Class 4 impacts.

- a. Class 1 UL 2218 impacts resulted in passing rates for about 60 percent of the impact locations on the premium architectural shingle products.
- b. Class 2 UL 2218 impacts resulted in passing ratings for about 45 percent of the impact locations on the premium architectural products.
- c. Class 3 UL 2218 impacts resulted in passing ratings for about 40 percent of the impact locations on the premium architectural products.
- d. Class 4 UL 2218 impacts resulted in passing ratings for about 35 percent of the impact locations on the premium architectural products.
- e. In all four classes of testing, the passing rate of the premium architectural products was higher than the basic products, but lower than the passing rate of the IR products.

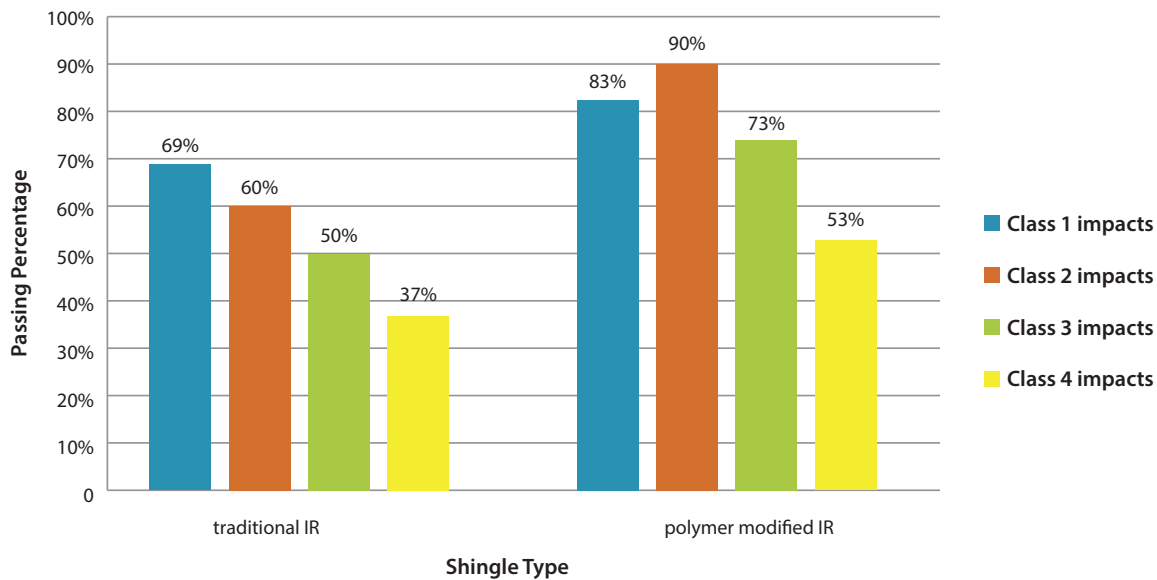
**UL 2218 Impact Location Passing Rates:
Polymer Modified IR vs. Traditional IR Shingles**

Figure 8. Comparison of traditional IR and polymer modified IR shingle performance to Class 1-4 impacts. It should be noted that these IR products are rated to withstand Class 4 impacts.

- a. Class 1 UL 2218 impacts resulted in passing ratings for about 85 percent of the impact locations on the polymer modified IR products compared to about 70 percent for the traditional IR shingles.
- b. Class 2 UL 2218 impacts resulted in passing ratings for about 90 percent of the impact locations on the polymer modified IR products compared to about 60 percent for the traditional IR shingles.
- c. Class 3 UL 2218 impacts resulted in passing ratings for about 75 percent of the impact locations on the polymer modified IR products compared to about 50 percent for the traditional IR shingles.
- d. Class 4 UL 2218 impacts resulted in passing ratings for about 55 percent of the impact locations on the polymer modified IR products compared to about 35 percent for the traditional IR shingles.

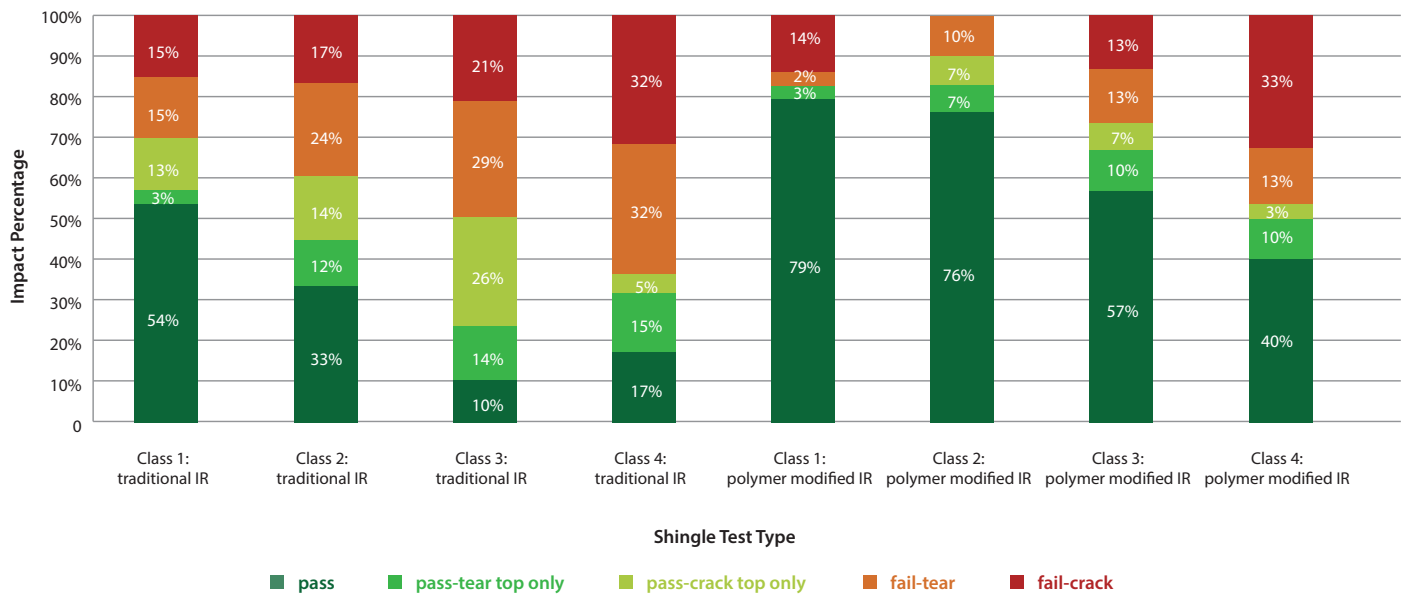
UL 2218 Performance Comparison:
Traditional IR vs. Polymer Modified IR Shingles

Figure 9: Detailed analysis of passing and failure modes for traditional IR and polymer modified IR shingles. It should be noted that the IR products are rated to withstand Class 4 impacts.

An example of this more detailed analysis is provided in Figure 9 (page 14), which shows that polymer modified IR shingles perform better in each impact test class than the traditional IR shingles. From this dataset, polymer modified products are less likely than traditional products to have a crack visible on the top without also being visible on the bottom. They also are less likely to exhibit tears at edges and corners and the dominant damage mode is cracking at joints and shingle centers.

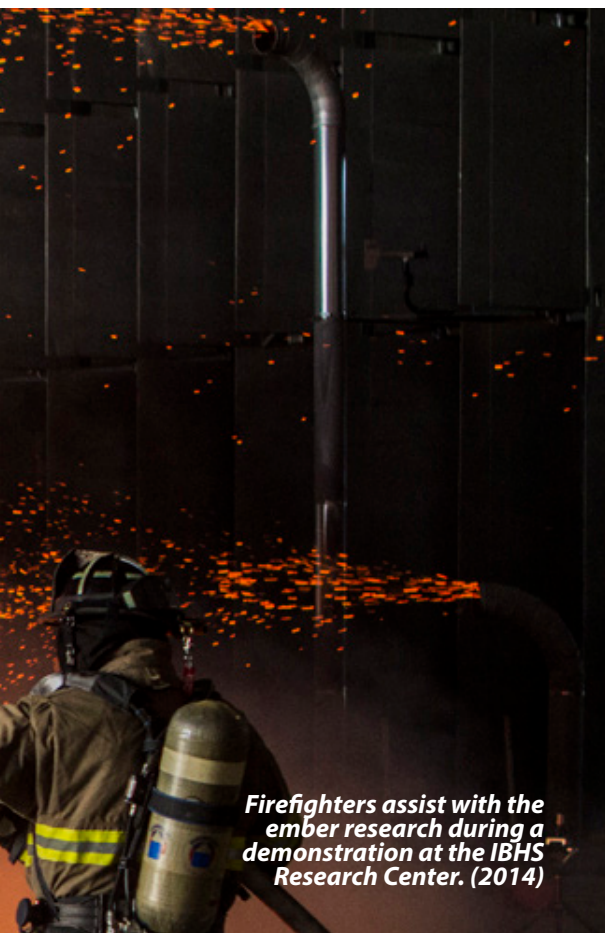
Firefighters assist with the ember research during a demonstration at the IBHS Research Center. (2014)

thereby reducing property damage. One way is isolating how embers enter the vents in the attic spaces of a home. Once in the attic, embers can ignite combustible materials there, and subsequently burn the house from the inside out.”

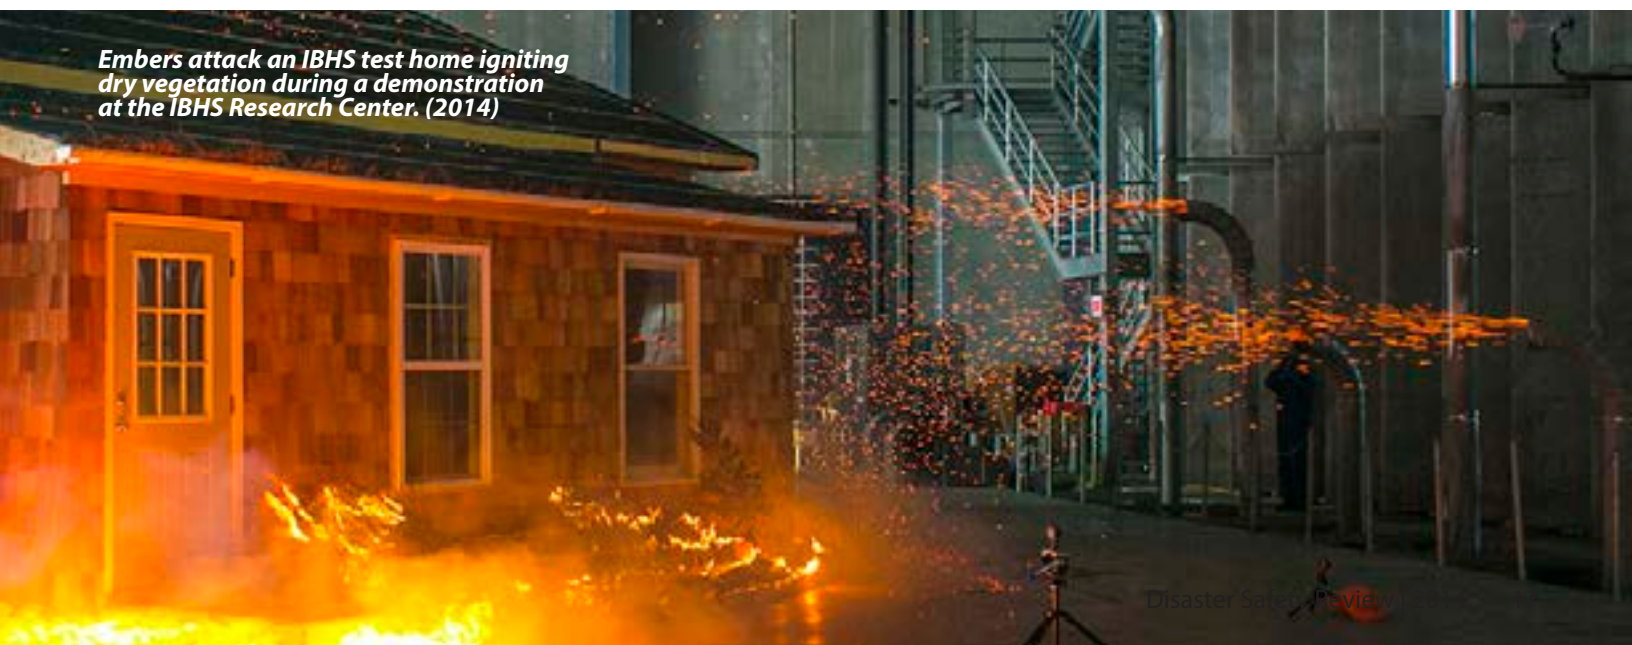
Embers attack an IBHS test home igniting dry vegetation during a demonstration at the IBHS Research Center. (2014)

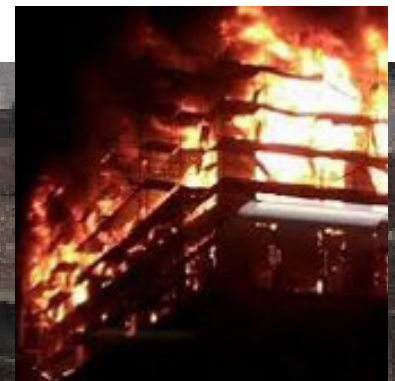
Above: Fire in progress.
Left: Aftermath of the fire, taken from EMC Insurance's Hub Tower, overlooking their damaged East Building (left) and what's left of the historic Yunkers Building (right).

Inspection of their buildings found exterior water damage from the firefighting operations, exterior window damage in two buildings, and some ember damage on the roof of their home office building. Because they had invested in Visionwall® high performance windows, no water or smoke damage occurred inside the office space. The windows, however, cracked on the outside, which resulted in glass falling on the streets around the buildings. Consequently, many windows in both buildings had to be replaced. While significant interior damage did not occur, EMC still brought in a recovery company to clean the office space and make sure they were ready for employees. **DSR**
